Clouds and the Earth's Radiant Energy System

CERES FM6 Calibration Subsystem Performance Issues

Kory Priestley - Project Scientist
Audra Bullock - Chief Engineer

CERES Science Team Meeting
NASA LaRC
May 7, 2013

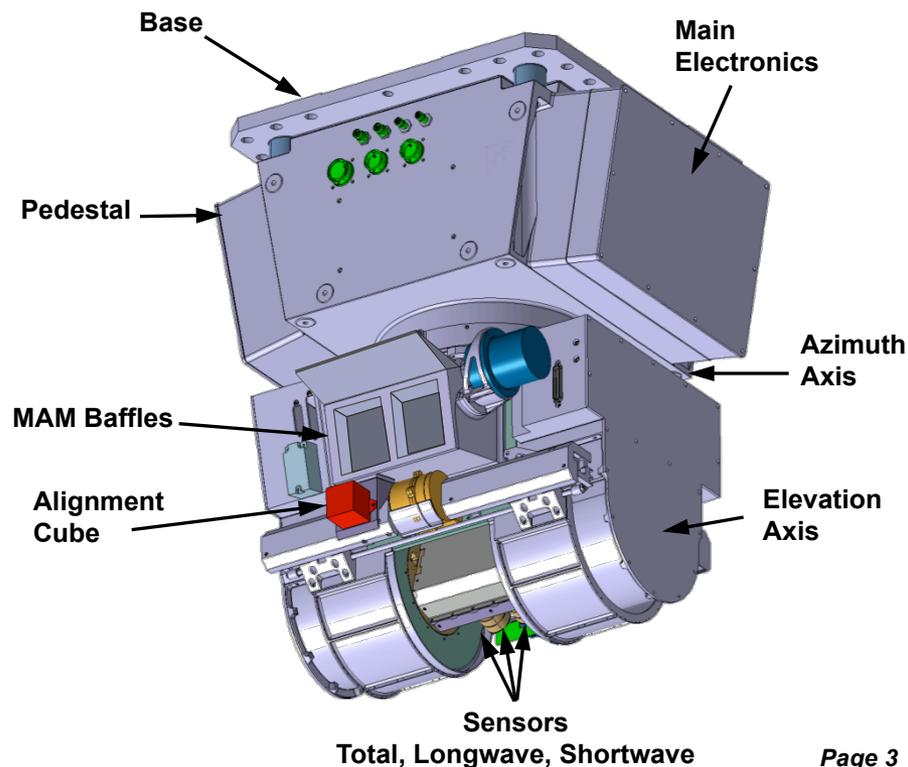
- **Designed, manufactured and tested by TRW, Redondo Beach, CA (currently Northrop Grumman Aerospace Systems)**
- **Contains three sensor assemblies with cassegrain optics and thermistor bolometer detectors**
- **Sensors measure thermal radiation in the near-visible through far-infrared spectral region**
- **Sensor channels are coaligned and mounted on a spindle that rotates about the elevation axis**
- **Hemispherical sampling obtained with an azimuthal axis drive system**

Orbits	705 km altitude, 10:30 a.m. descending node (Terra) or 1:30 p.m. ascending node (PM-1), sun-synchronous, near-polar; 350 km altitude, 35° inclination (TRMM)
Spectral Channels	Solar Reflected Radiation (Shortwave): 0.3 - 5.0 μm Window: 8 - 12 μm , 5 - 40 μm (FM6) Total: 0.3 to > 100 μm
Swath Dimensions	Limb to limb
Angular Sampling	Cross-track scan and 360° azimuth biaxial scan
Spatial Resolution	20 km at nadir (10 km for TRMM, 28 km for NPP)
Mass	45 kg
Duty Cycle	100%
Power	45 W
Data Rate	10 kbps
Size	60 x 60 x 70 cm (deployed)
Design Life	6 years

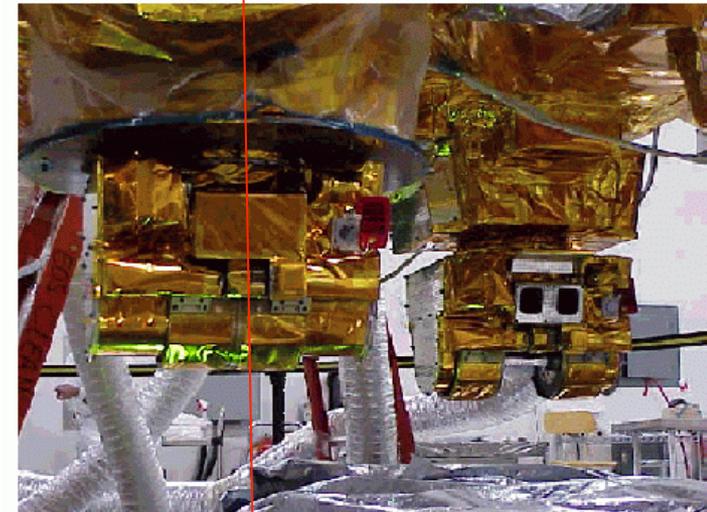
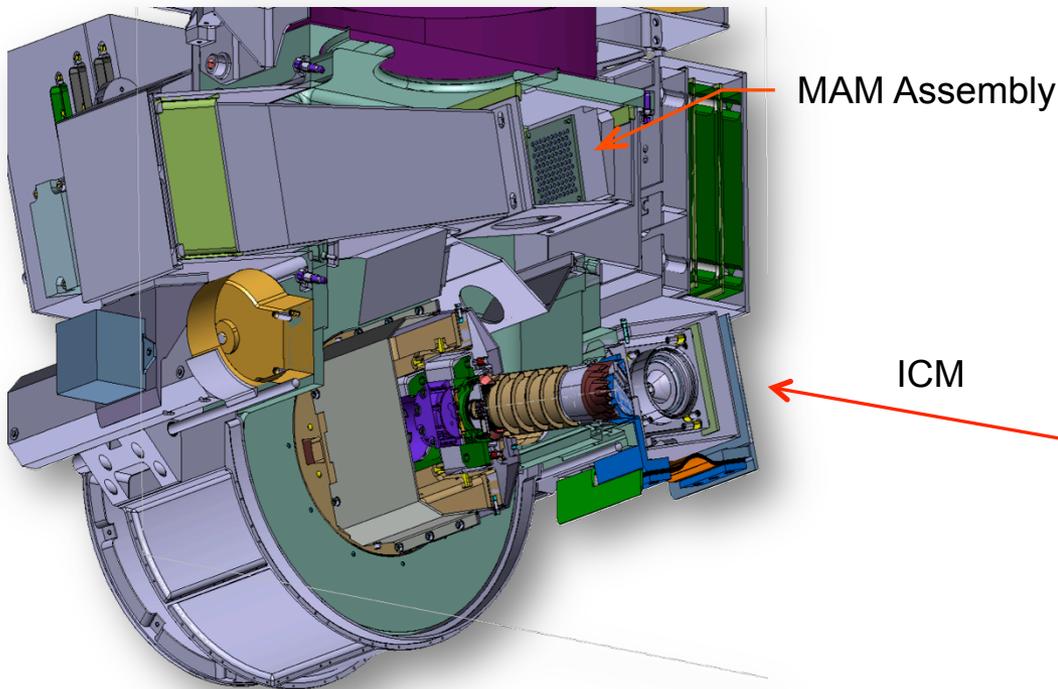
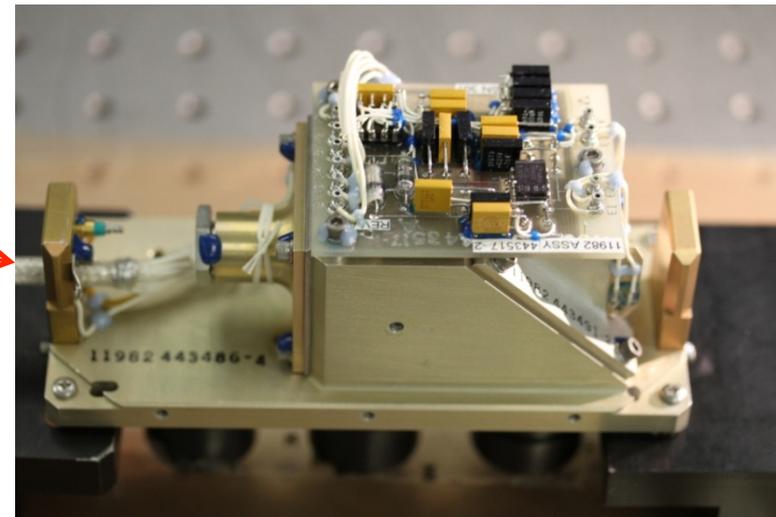
2 MAMs installed in CERES Instrument: SW & Total

- Mirror Attenuator Mosaics (MAMs) *diffuse* and *attenuate* incident solar energy so that the CERES Shortwave and Total Channels are presented with repeatable, on-scale radiance scenes over the range of incident angles experienced during periodic, on-orbit, solar calibrations.
- MAMs fabricated for FM6 are different than prior flight units
 - Substrate is Diamond Turned Aluminum vs. Electroformed Nickel
 - Coatings updated for improved resistance to Atomic Oxygen
- Why did we change Fab process?
 - Diamond turned aluminum substantially easier to fabricate than electroformed nickel and electroform/grinding process has low yield ~25%.

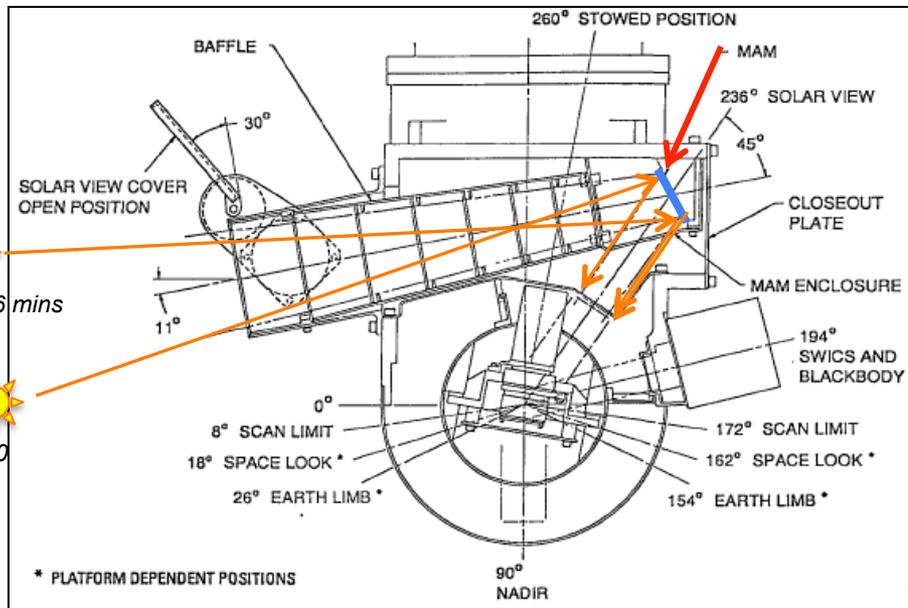
CERES MAM Assembly

MAM Goal
minimize variability in reflected solar energy over all incident angles

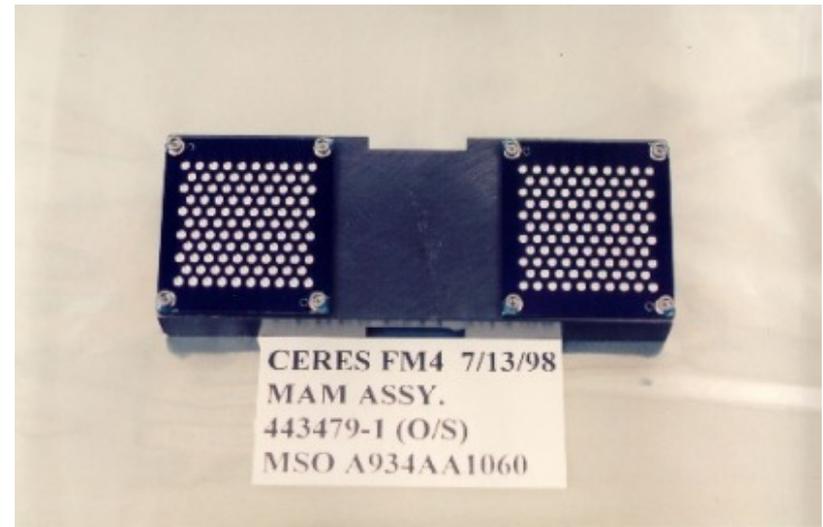
Uniformity Requirement $\pm 1\%$ over 4.5° Solar Angle

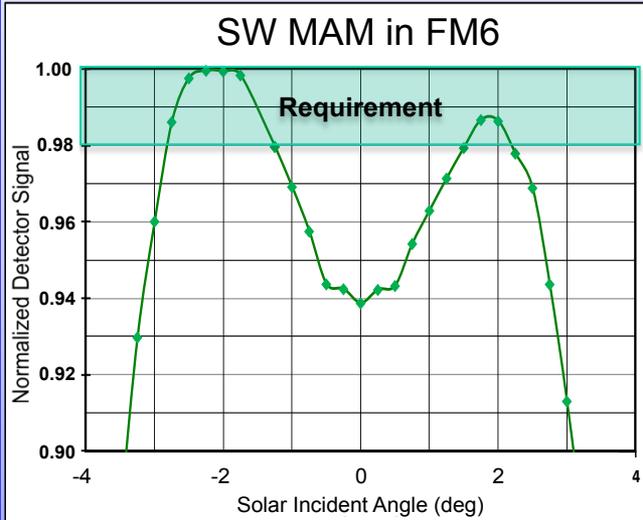
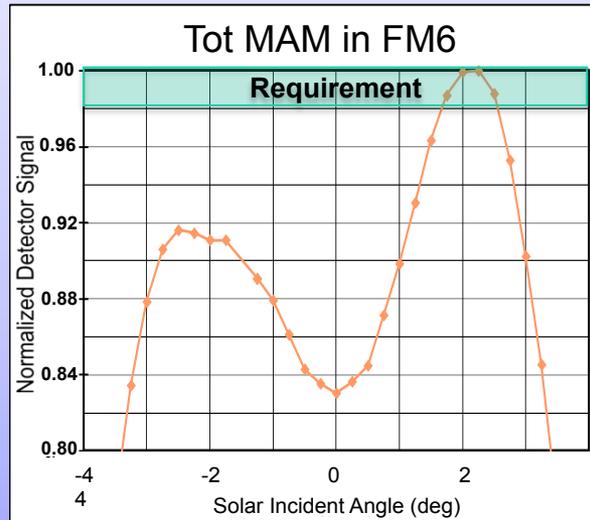
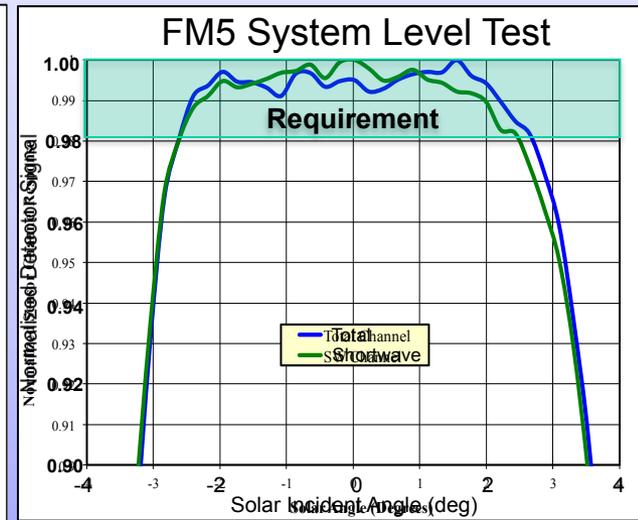
Two contributors identified:

- Solar Simulator non-uniformity
- Diamond-turning resulted in fringed scatter pattern

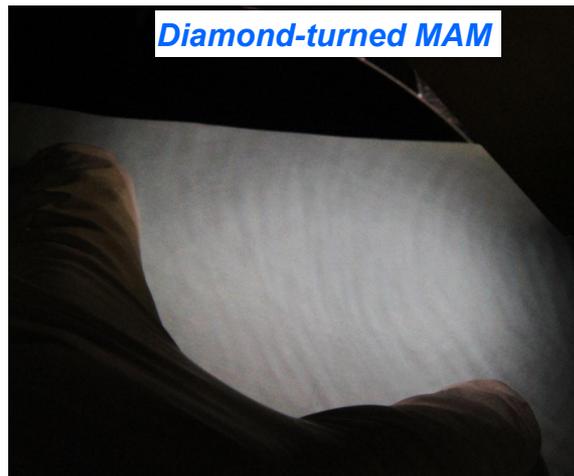
Diamond-turned vs Nickel MAM Laser Illuminating Single Dimple

The diamond-turning process is plagued with issues of tooling marks

Diamond-turned MAM
Tooling marks cause fringed scatter

- Isolate Performance Problem
 - Diamond-Turned Tooling marks have been identified as the source of MAM performance issue
- Select replacement flight MAM from CERES heritage MAMs
 - Pe-condition MAM using AO asher from GRC
- Verify ICM performance in vacuum
- Verify Instrument Performance
- Conduct SAR/PSRR

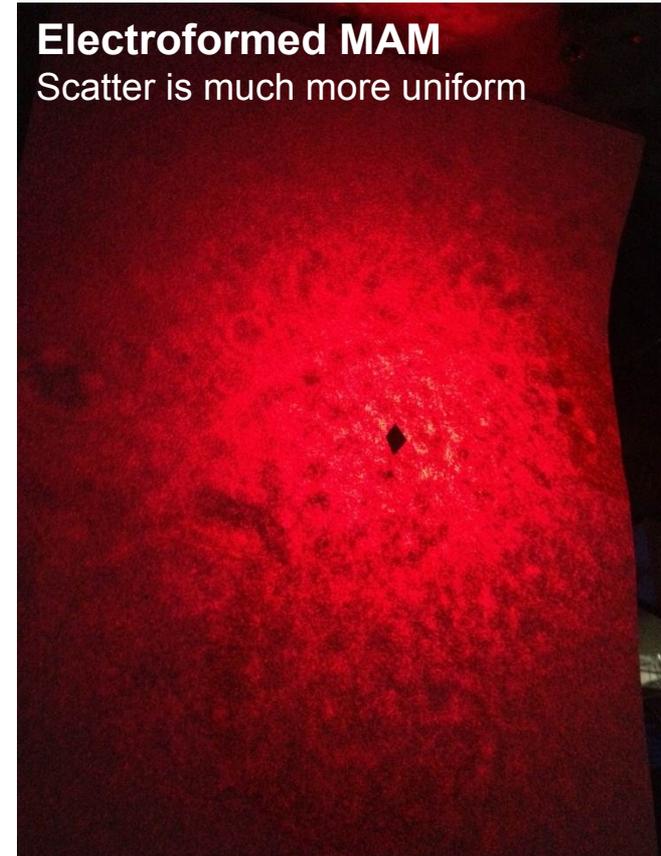
Electroformed MAM
Scatter is much more uniform

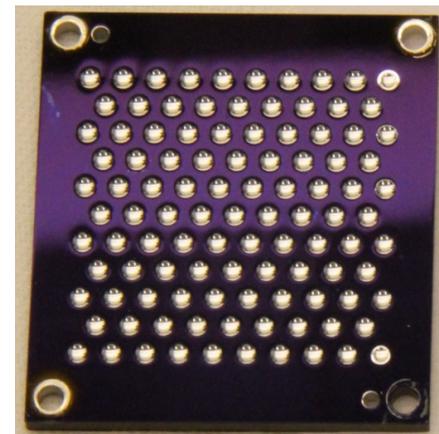
S/N E1/B3

◆ NG located 2 legacy MAMs of the FM4 vintage

- Parts removed from flight status in late 90's for surface blemishes
- Parts bagged and stored in controlled environment during interim

◆ Scatter uniformity meets requirements with margin

◆ AO coating susceptibility corrected

- LaRC & NG collaborated with GRC to fully oxidize protective coating (*Complete*)

◆ MAMs upscreened and ready for installation 3 weeks ahead of schedule

- Coating adhesion testing (*Complete*)
- Component scatter test post AO exposure (*Complete*)

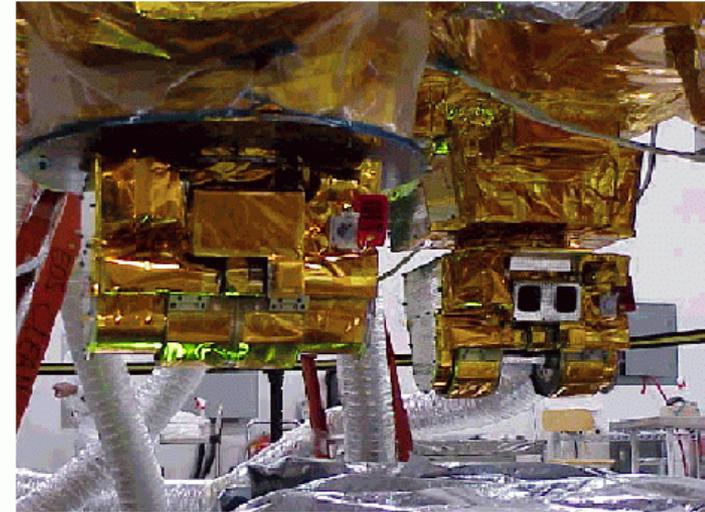
1. Solar Diffuser Mirror Attenuator Mosaic (MAM) scatter non-uniformity
2. *Internal Calibration Module (ICM) lamp brightening*
3. *Internal Calibration Module (ICM) photodiode reference detector response decrease*

- Isolate Performance Problems
 - ICM Vacuum Test determined the Lamp and PD performance issues are confined to the ICM
 - ICM Diagnostic Test to further isolate performance issues
- Select replacement flight Lamp and PD from CERES heritage or CERES FM6 parts

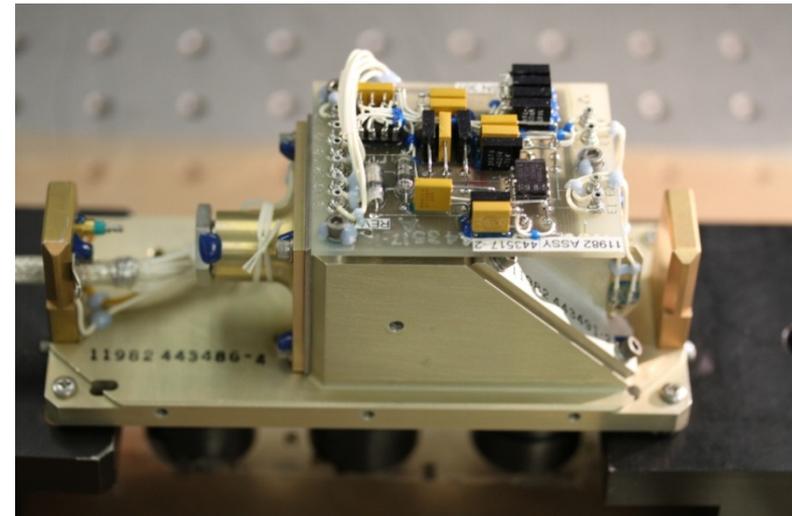
ICM contains 2 subassemblies

Shortwave Internal Calibration Source (**SWICS**):

- Lamp and focusing optics
- Reference Detector
- Folding Mirror

Internal BlackBody (**IBB**):

- Concentric grooved blackbodies
- Heaters and PRTs

*During Calibration we view the SWICS lamp with two independent detectors
CERES SW sensor and Reference Photodiode*

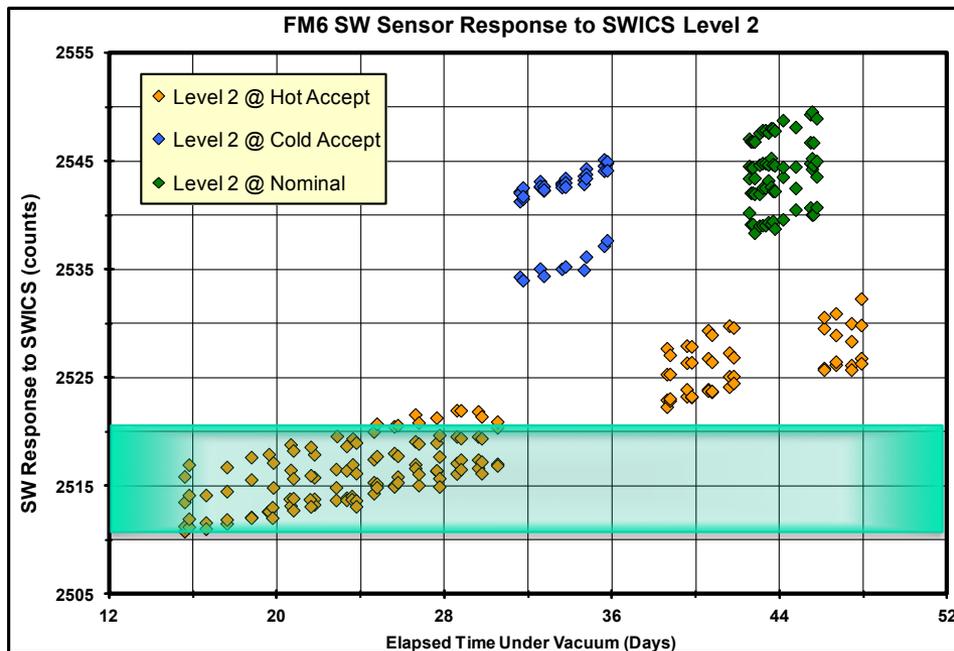
Instability of SWICS Lamp and Photodiode (Instrument Level Testing)

The trends in the data below should be **consistent or preferably flat**.

Light Source : SWICS Lamp
 Detector : CERES SW Channel
 Conclusion : SWICS Lamp appears to be getting brighter

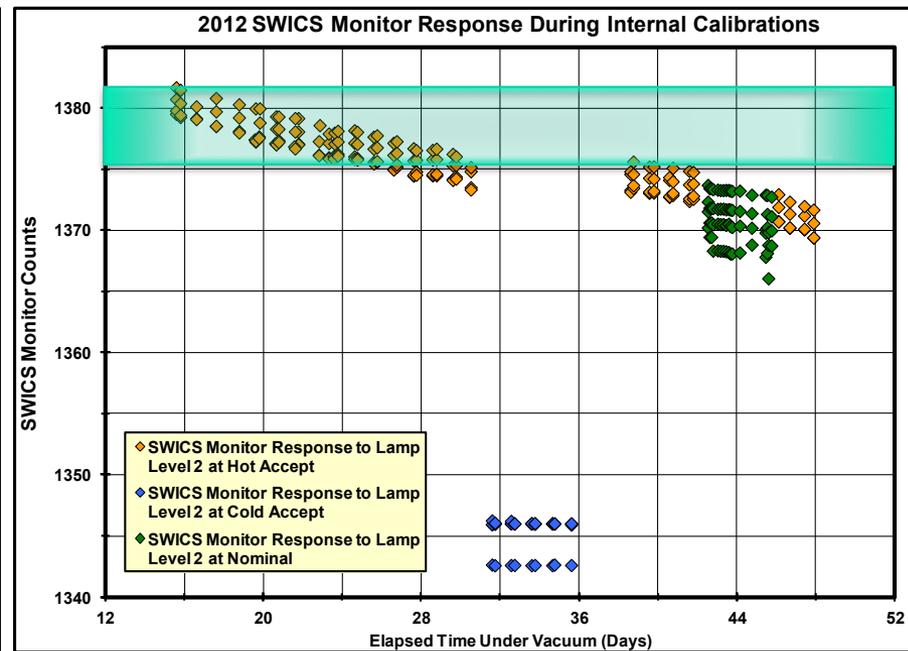
Light Source : SWICS Lamp
 Detector : SWICS Photodiode Reference Detector
 Conclusion : Photodiode Response Decreasing

- ◆ ICM removed from instrument and tested under vacuum (Oct 2012, Jan 2013)
- ◆ Module-level test results *consistent* with instrument-level calibration (FM6 Instrument exonerated)
- ◆ Shifts with temperature are artifact of sensor and BB heater drive ground bias effect
- ◆ PD Data uncorrected for apparent source drift
- ◆ PD Response Drift Rate is a function of Instrument Temperature

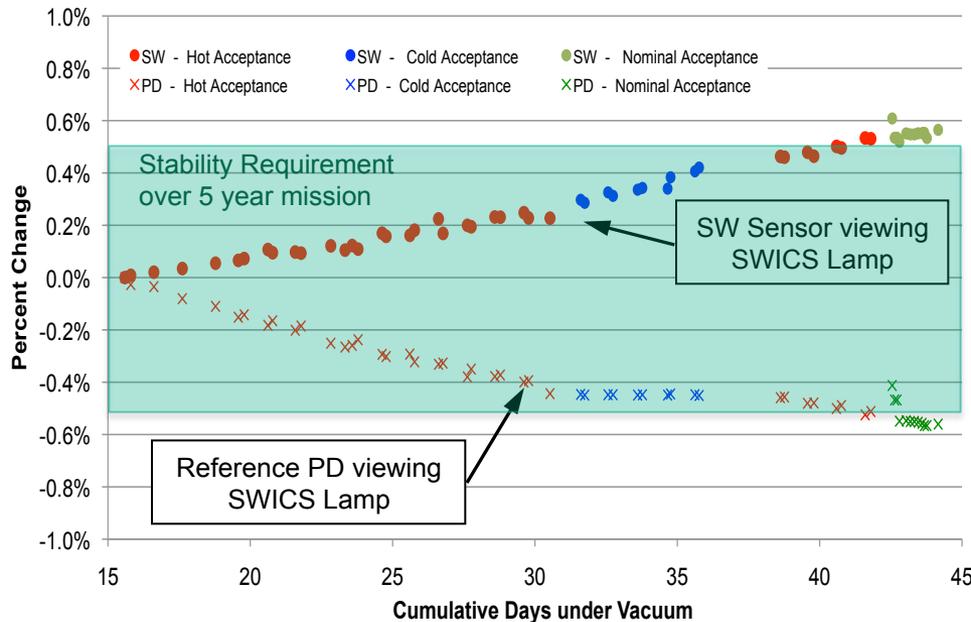
Instrument Level Calibration Test

Instability of SWICS Lamp and Photodiode (Instrument & Module Level Testing)

The trends in the data below should be consistent or preferably flat.

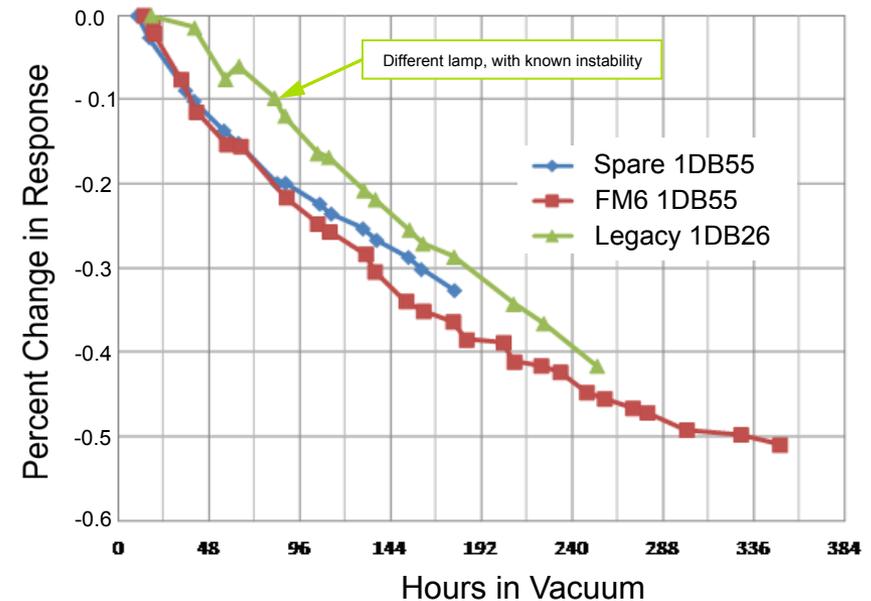
Module Level PD Test

- ◆ ICM removed from instrument and tested under vacuum (Oct 2012, Jan 2013)
- ◆ Module-level test results consistent with instrument-level calibration (FM6 Instrument exonerated)
- ◆ PD Data uncorrected for apparent source drift
- ◆ PD Response Drift Rate is a function of Instrument Temperature

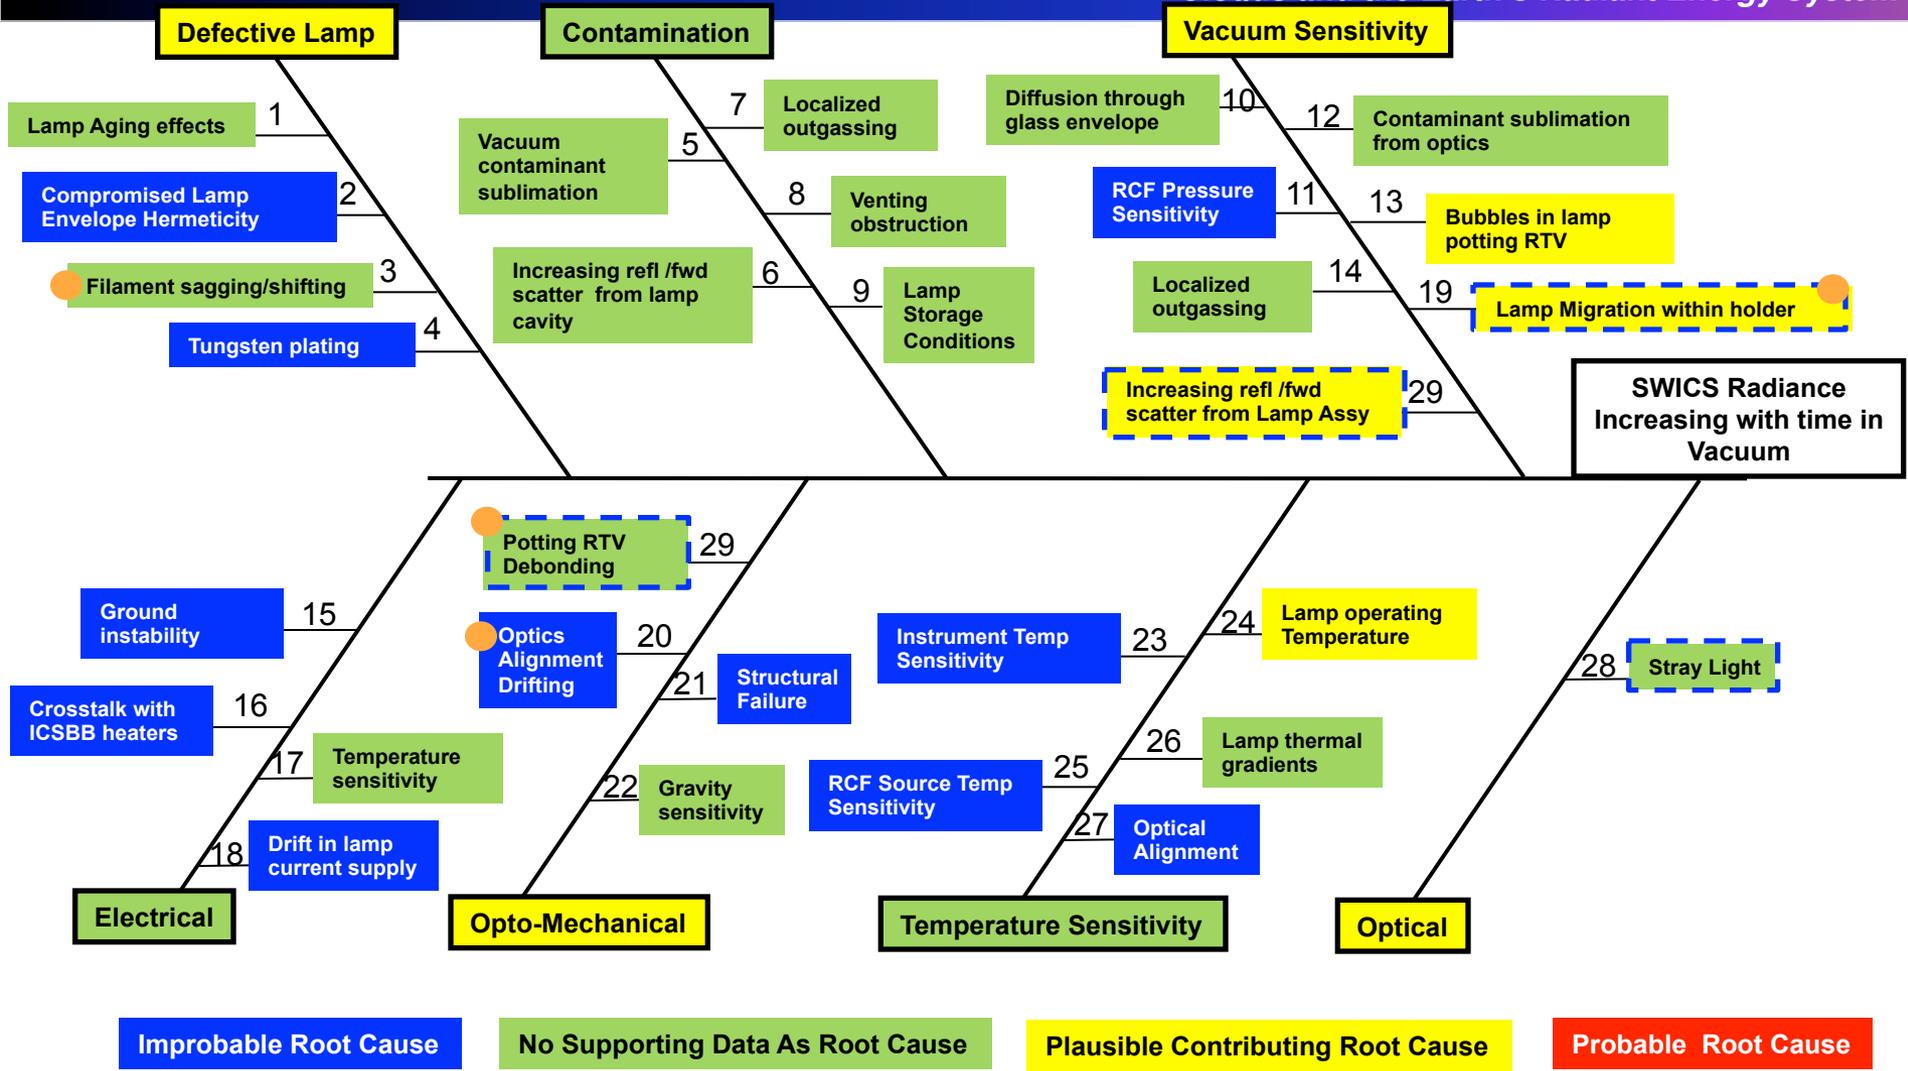
Fishbone Diagram: Increasing SWICS Radiance

● May also explain apparent PD response degradation

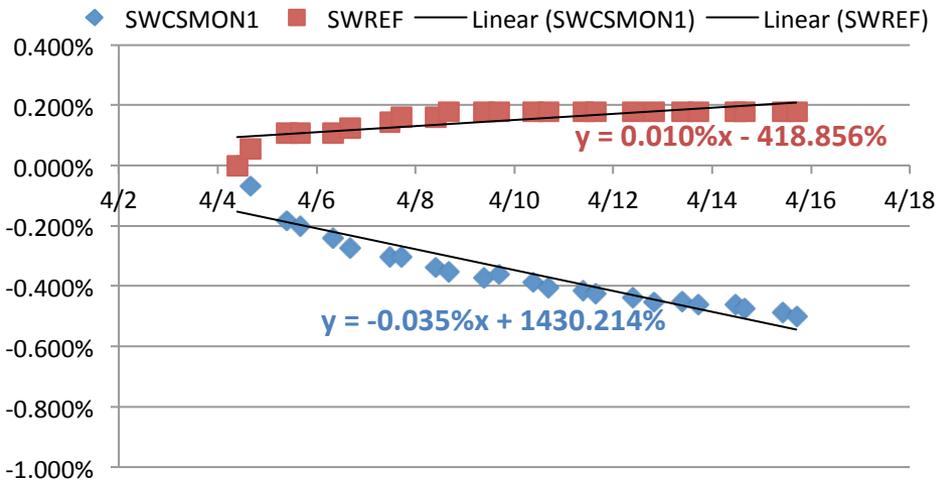
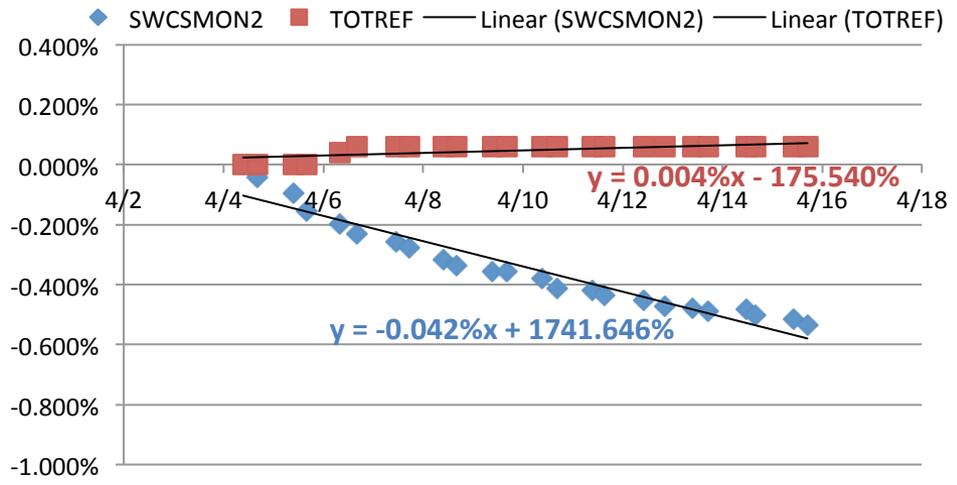
ICM: Flight candidate Lamp SN16, 1DB55 SN94 PD w placed Barr filter, SW Ref

BB: Flight candidate Lamp SN25, 1DB55 SN77 PD w/o filter, TOT Ref

Summary: Lamp SN24 and 1DB55 SN94 w placed filter performed best

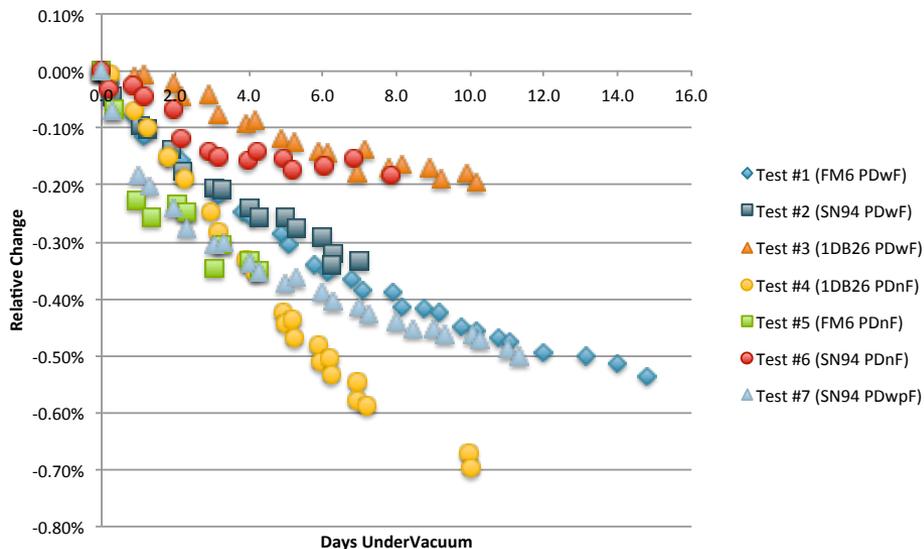
ICM Vacuum Test: Photodiode Performance Comparison

Note- Results uncorrected for measured lamp drift

- ◆ Photodiodes have trended negative in every test configuration
- ◆ 1DB55 PDs tend to exhibit decreasing slope with time in vacuum
- ◆ 1DB55 SN94 remains leading PD candidate

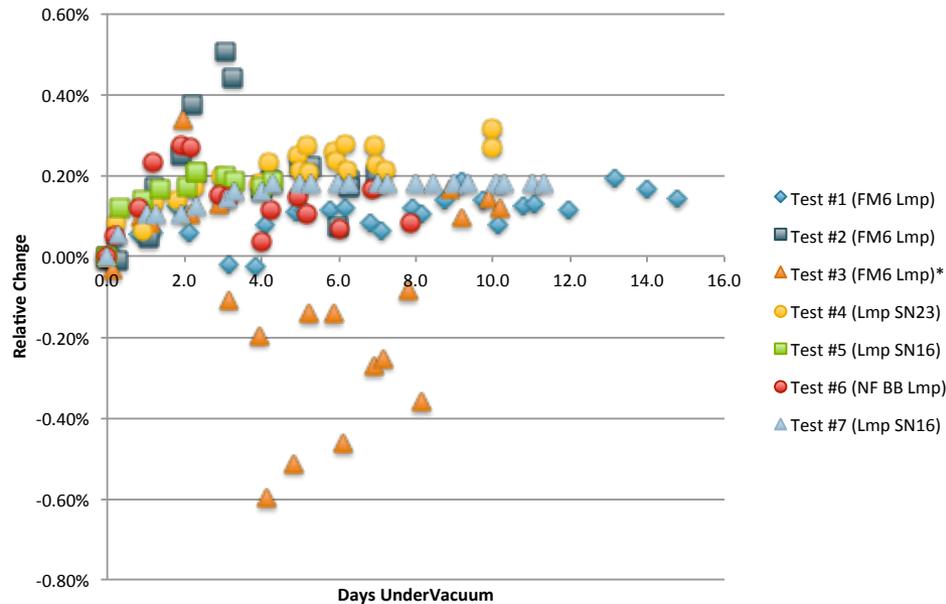
ICM Vacuum Test: Lamp Performance Comparison

Results measured with Thermopile reference detectors

- ◆ Data from Test #3 is suspect due to mechanical crosstalk causing dual-off-state level
- ◆ Non-flight BB lamp is the only one to show a negative trend
- ◆ Lamps appear to have a vacuum stabilization period in the ICM
